ok
**(OPERATION OF A FORCED CIRCULATION,
HAYNES ALLOY NO. 25, MERCURY LOOP
TO STUDY CORROSION PRODUCT
SEPARATION TECHNIQUES)**

OPERATION OF A FORCED CIRCULATION, HAYNES ALLOY NO. 25,
MERCURY LOOP TO STUDY CORROSION PRODUCT
SEPARATION TECHNIQUES

This report is concerned with the construction, operation, and evaluation of a forced circulation mercury loop designed to investigate corrosion product separation techniques in a Haynes alloy No. 25 system. The work was performed between May 1962 and April 1964 in support of the Sunflower program under NASA Contract NAS 5-462 with Mr. Jack A. Heller, Space Power Systems Division, NASA Lewis Research Center, as Technical Manager. The report was originally prepared as Thompson Ramo Wooldridge Report ER-5985, May 1, 1964.

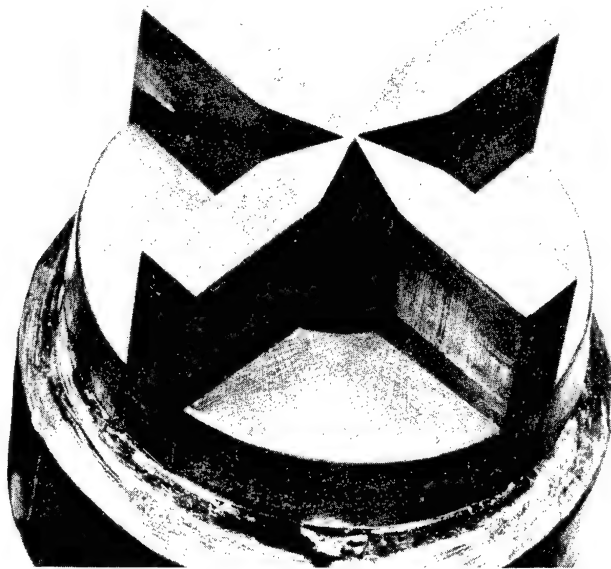
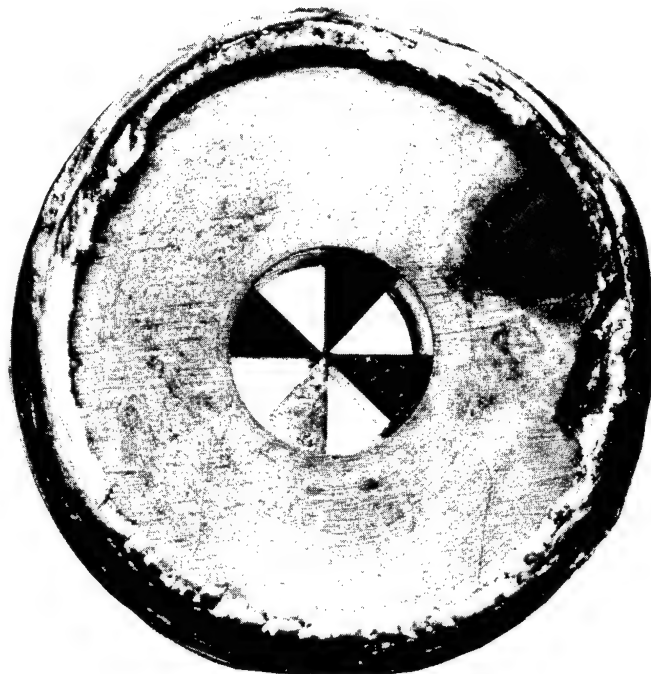
Figure 17. Deposit Found in Loop Nozzle.

The nozzle was also observed to contain a deposit, as shown in Figure 17. Although there was a small amount of deposition on the inlet side, the majority of the deposit was found on the outlet.

The nozzle, made from Nivco 10, suffered up to five mils of penetration on both the inlet and outlet sides. (Immersion thermocouples recorded 867 and 862°F as the inlet and outlet temperatures, respectively, of the mercury vapor, indicating that condensation was also occurring in this area.) The corrosion was manifested as intergranular penetration, Figure 26b. Some deposition was also apparent on the converging nozzle surfaces, Figure 27b. Heavy atmospheric oxidation was also evident on the nozzle inlet side, Figure 27a. The layer in the throat section could also be an oxide coating, Figure 27c. Oxidation undoubtedly occurred during the several shut down periods resulting from the faulty throttling valves. Although the loop was protected with an argon cover during these periods, complete protection could not be given to this region of the system until the loop had cooled to room temperature.

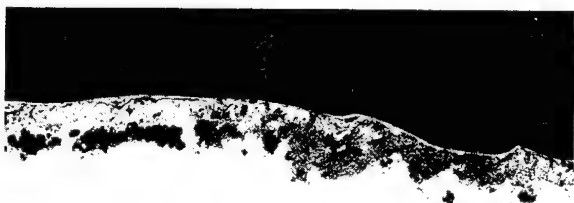
a) Section 12
Pre-Heater Inlet
(Crevice and Layer Attack)

b) Section 11
Pre-Heater Mid-Section
(Layer Attack)

c) Section 8
Boiler Inlet
(Layer Attack)

d) Section 7
Boiler Mid-Section
(Layer and Intergranular Attack)

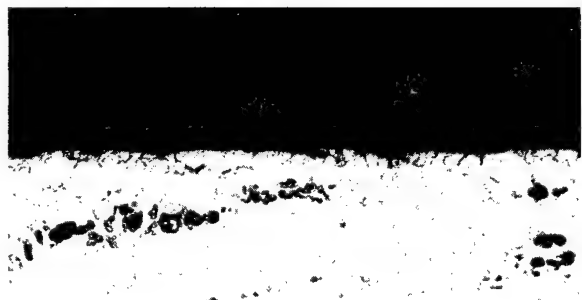
a) Inlet Side Oxidation

b) Throat Area
(Intergranular Attack)

c) Throat Area
(Deposition and
Intergranular Attack)

Figure 27. Cross-Sections of Nivco 10 Nozzle Inlet Side and Throat Showing Oxidation, Intergranular Penetrations, and Deposits. Magnification: 250X, Unetched.

Examination of the nozzle throat specimen (see Figure 27b) revealed a surface zone of intergranular precipitation extending to a depth of approximately 70 microns. A series of large gray precipitates near the base metal-end of the surface zone were also noted. The gray phases and oxides were found to be zirconium oxides that appeared to also contain some nickel in solution. These phases were identified as oxides since they yielded a visible fluorescence when struck by the electron beam. This fluorescence is typical of the presence of combined oxygen. The composition of the metal matrix surrounding the oxides was found to be essentially the same as the base metal. The concentration distributions for chromium and tungsten were consistent at less than 0.05 percent.

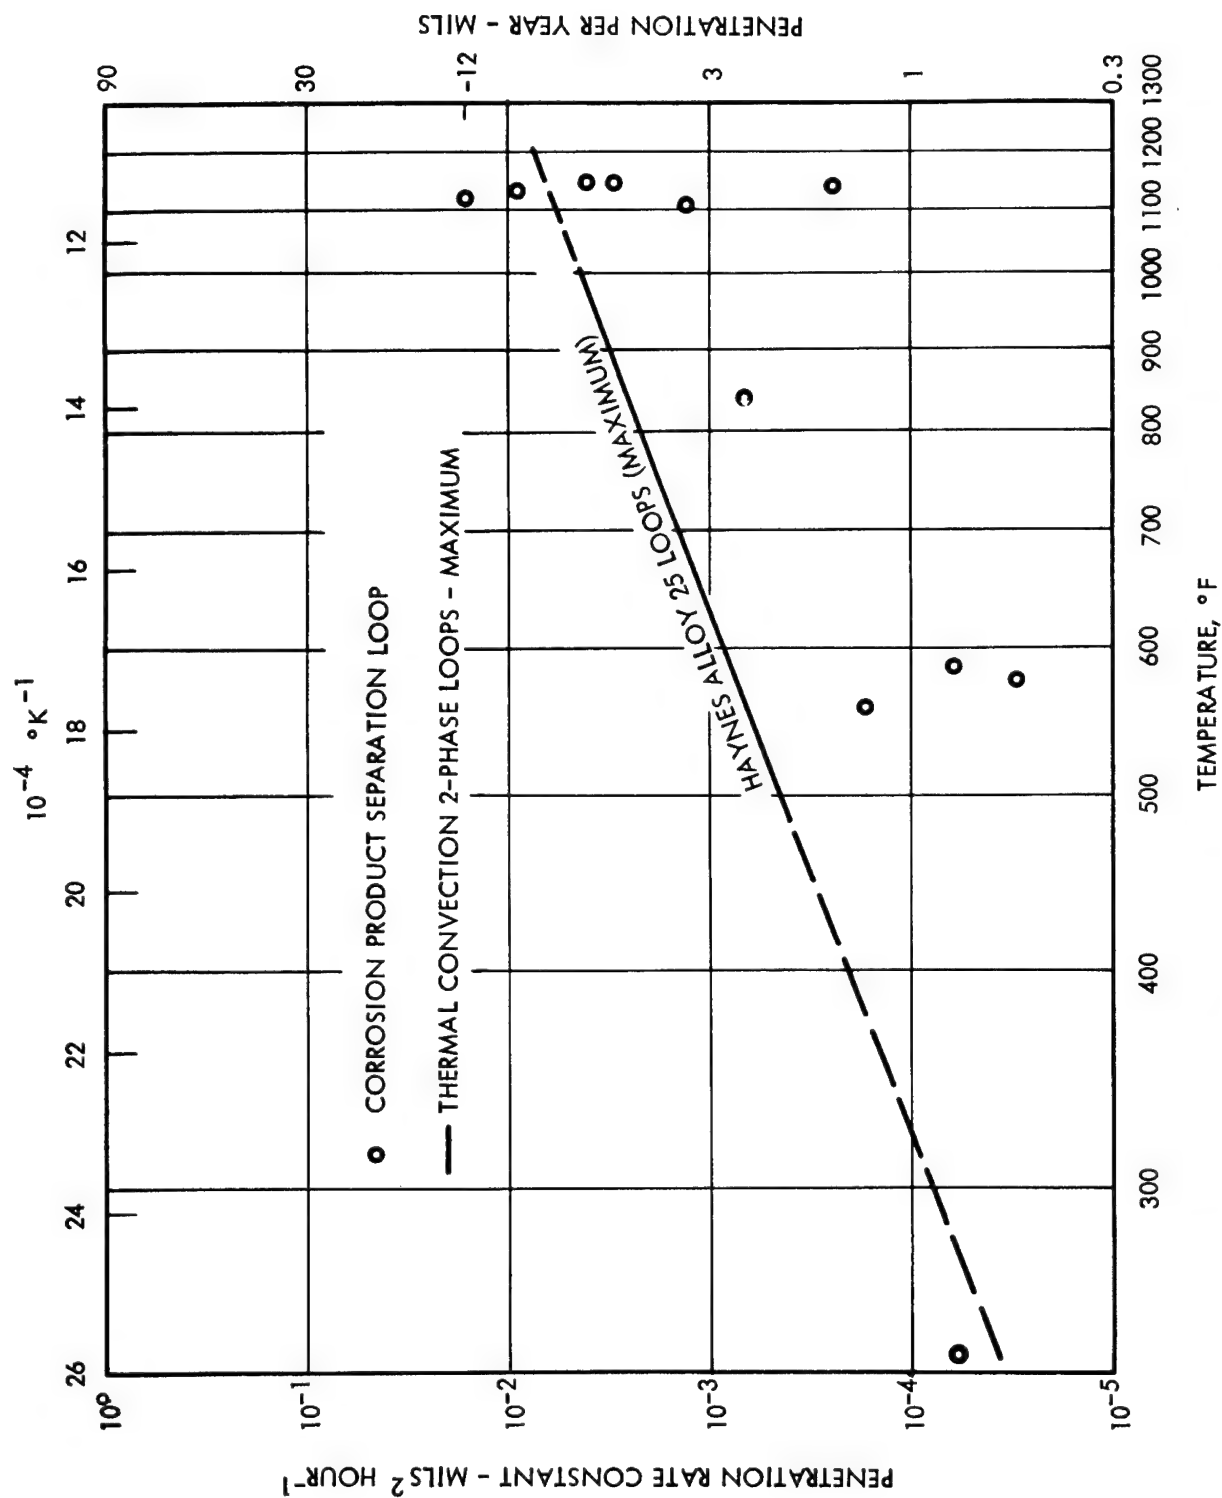
FIGURE 30. COMPARISON OF HAYNES ALLOY NO. 25 MERCURY PENETRATION FROM CORROSION PRODUCT SEPARATION LOOP WITH THERMAL CONVECTION, TWO-PHASE LOOPS (4).

Extrapolation of Figure 30 shows that, under the conditions of this loop test, a maximum penetration of 12 mils might be expected in a Haynes alloy No. 25 system operated for a year's duration. The average penetration, however, could be expected to fall in the range of 2 to 6 mils per year.

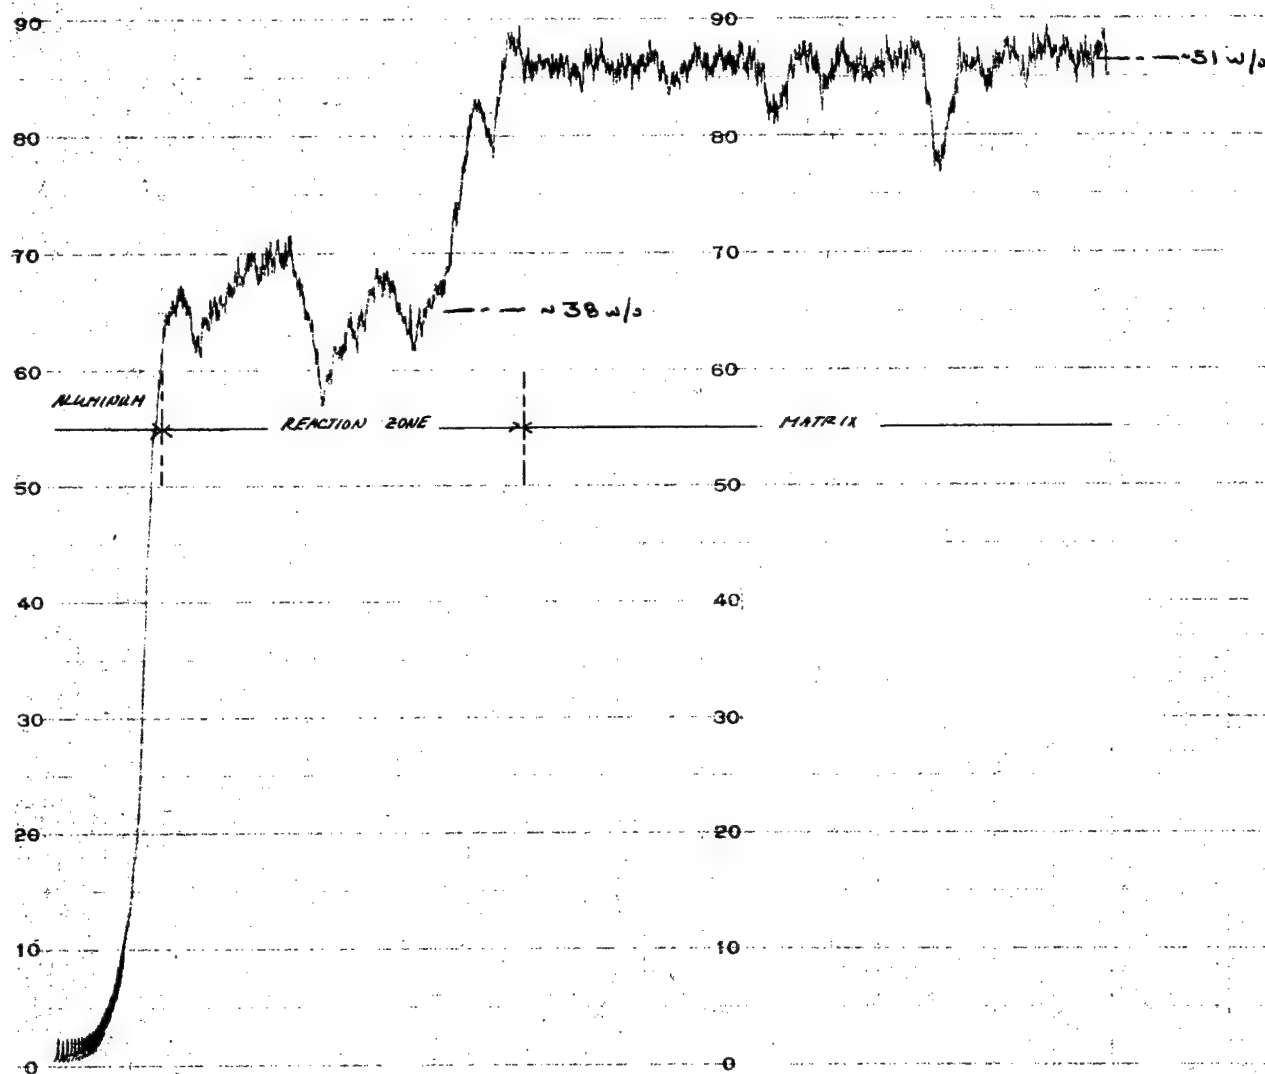
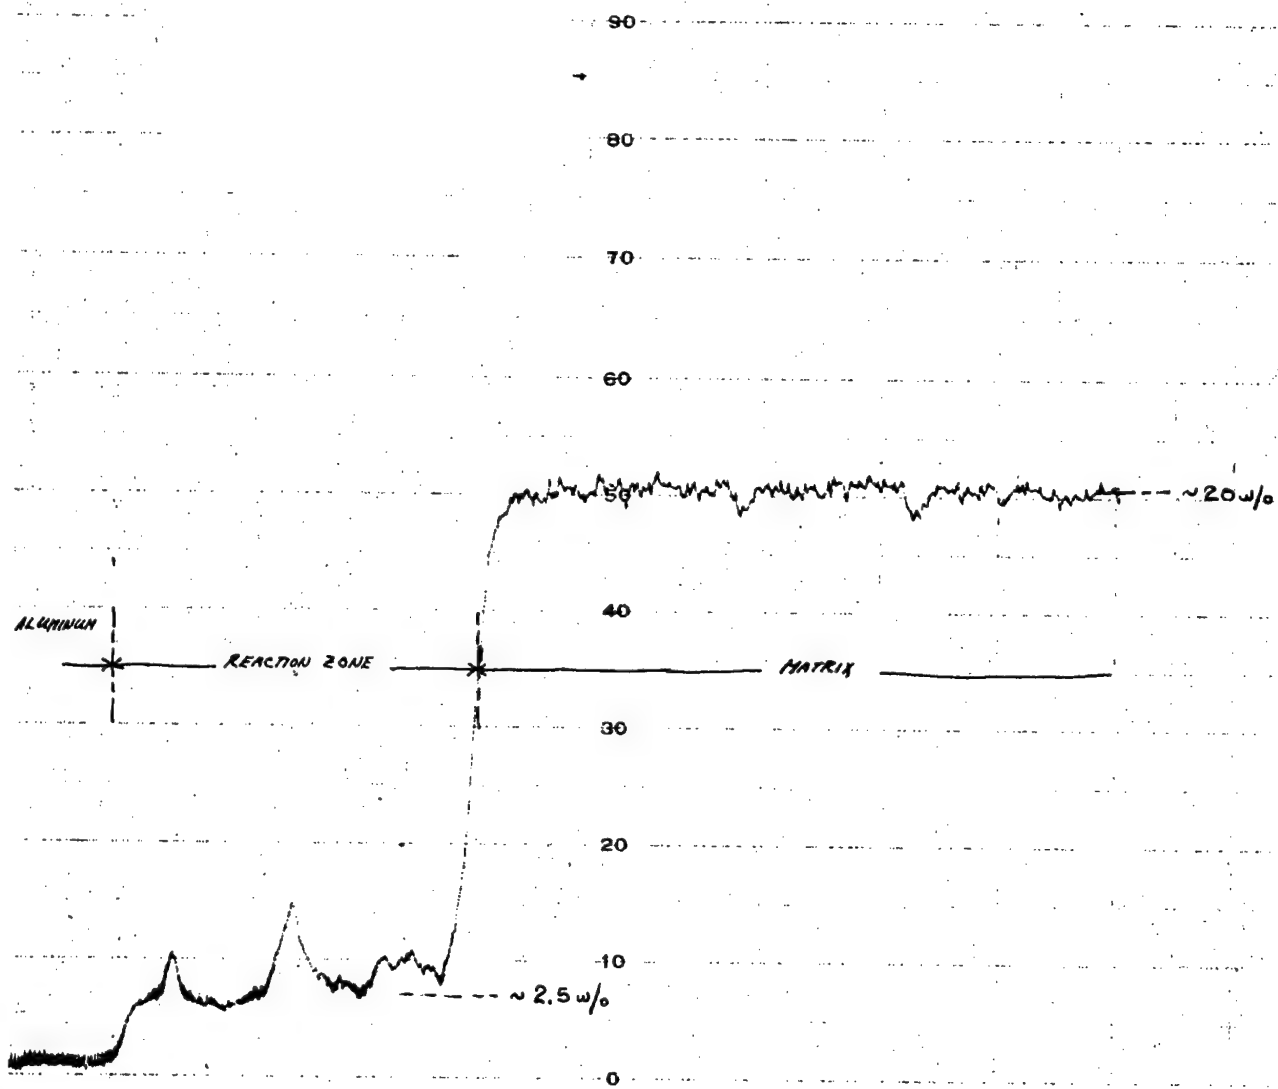
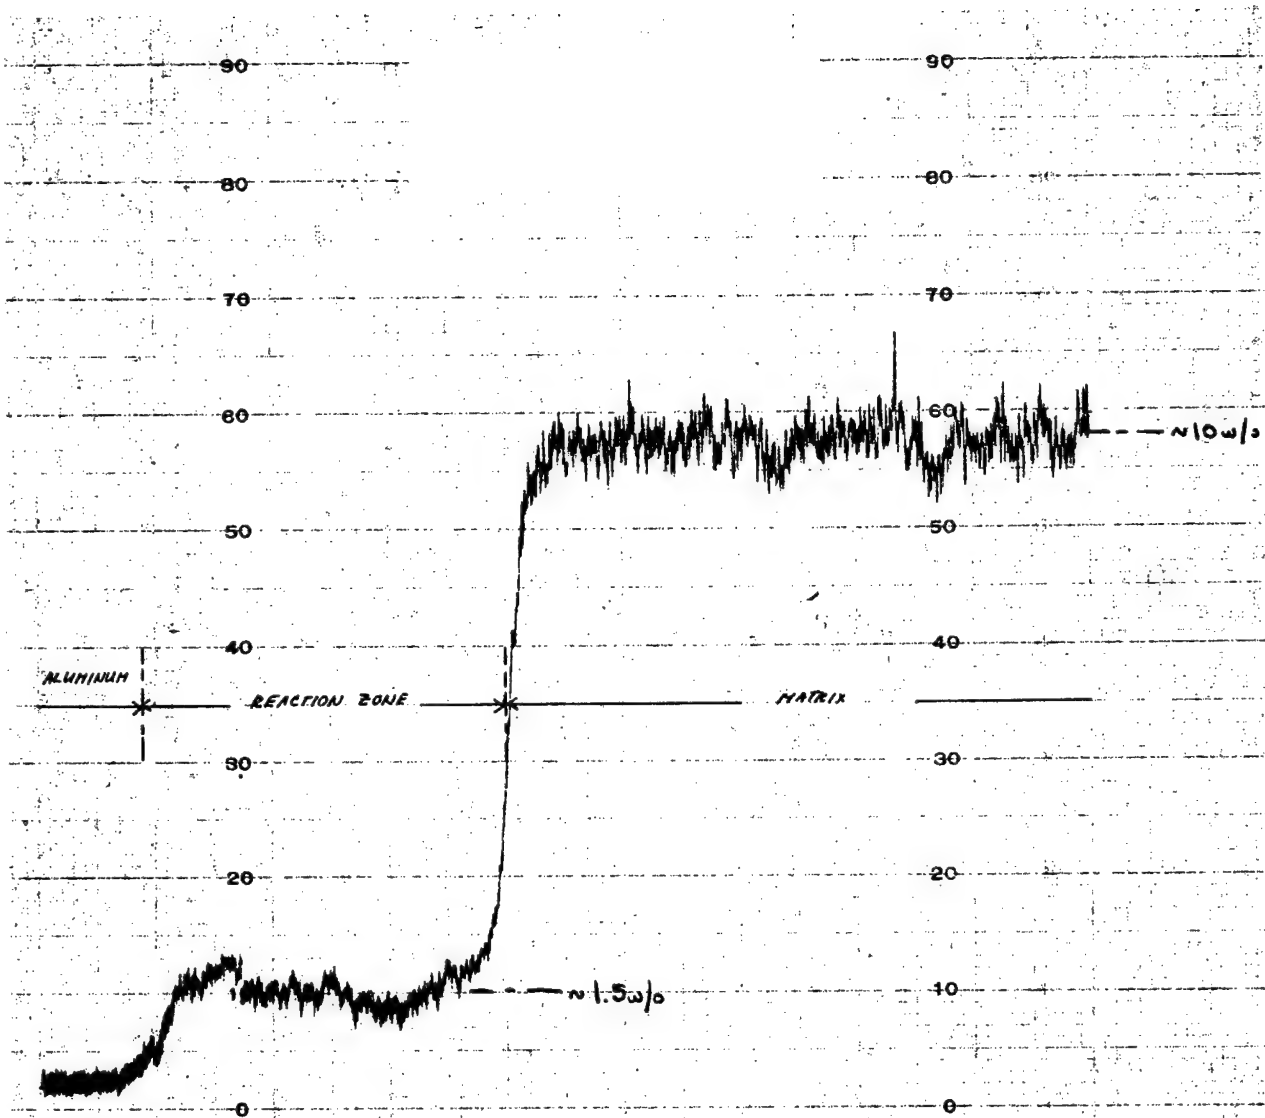
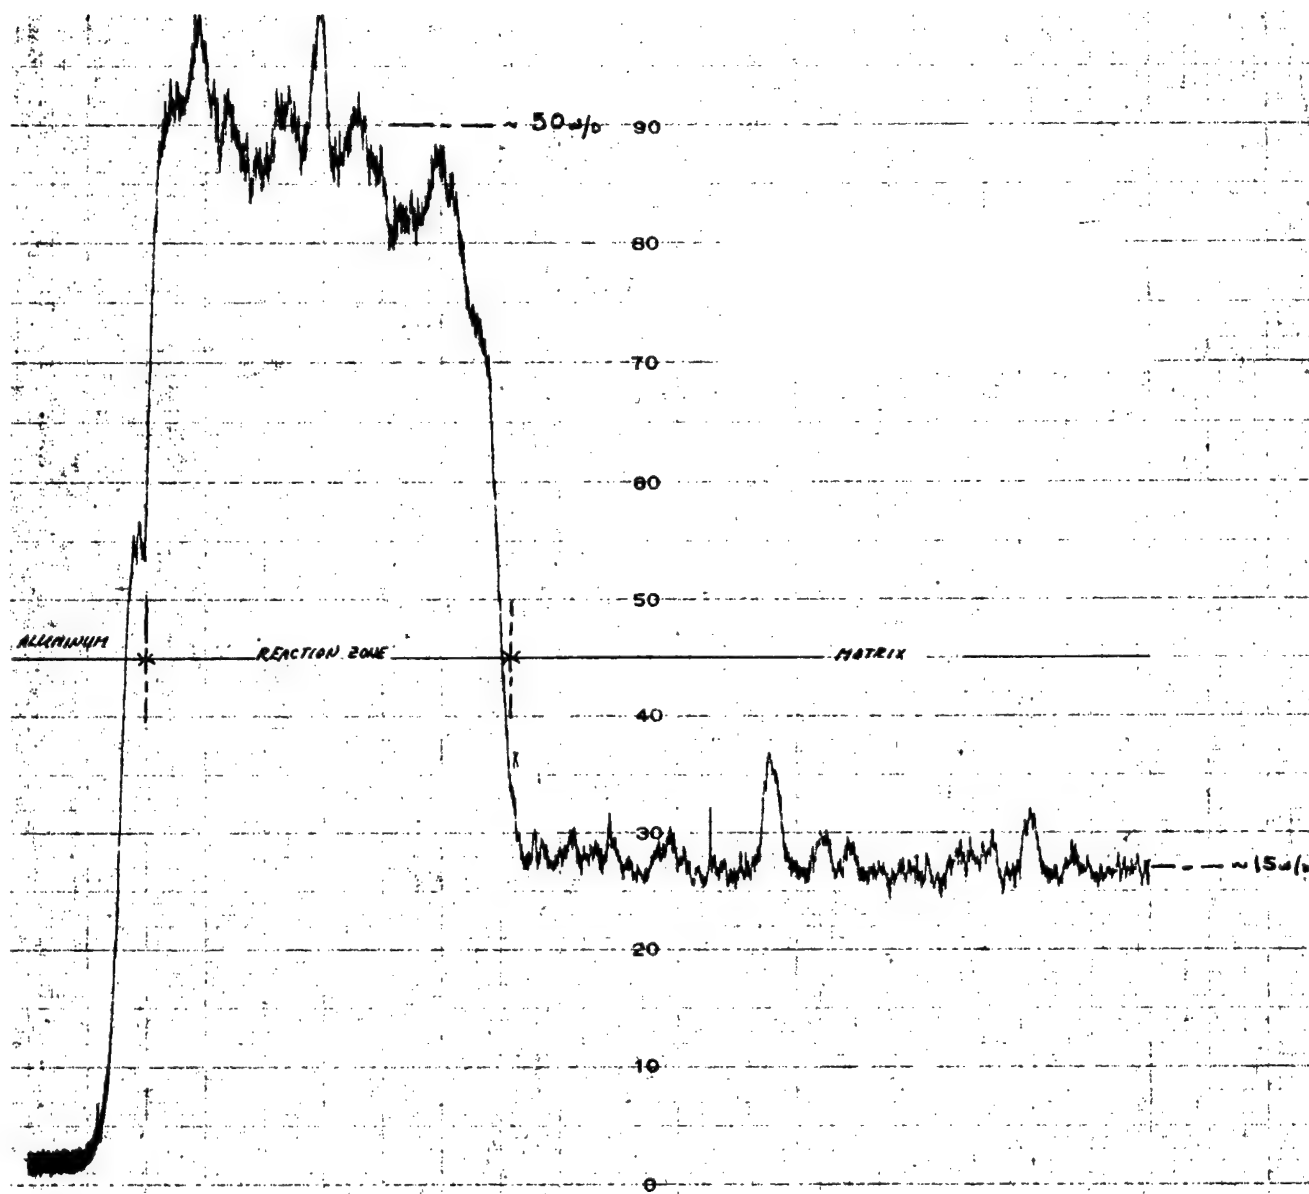
As seen in Figures 31 through 34, the electron beam microanalysis on the pre-heater outlet specimen (see Figure 20b) revealed a leached layer with an abrupt concentration discontinuity approximately 40 to 45 microns from the surface. The corrosion layer was found to be enriched in tungsten and depleted in nickel, chromium, and cobalt. Zirconium was found in the matrix as tungsten-zirconium carbides and comprised less than 0.05 percent. The zirconium concentration rose to 0.05 to 0.08 percent in the corrosion layer; however, the background intensity also rose as a result of the increased tungsten content. The titanium and columbium concentrations were consistently less than 0.05 percent.

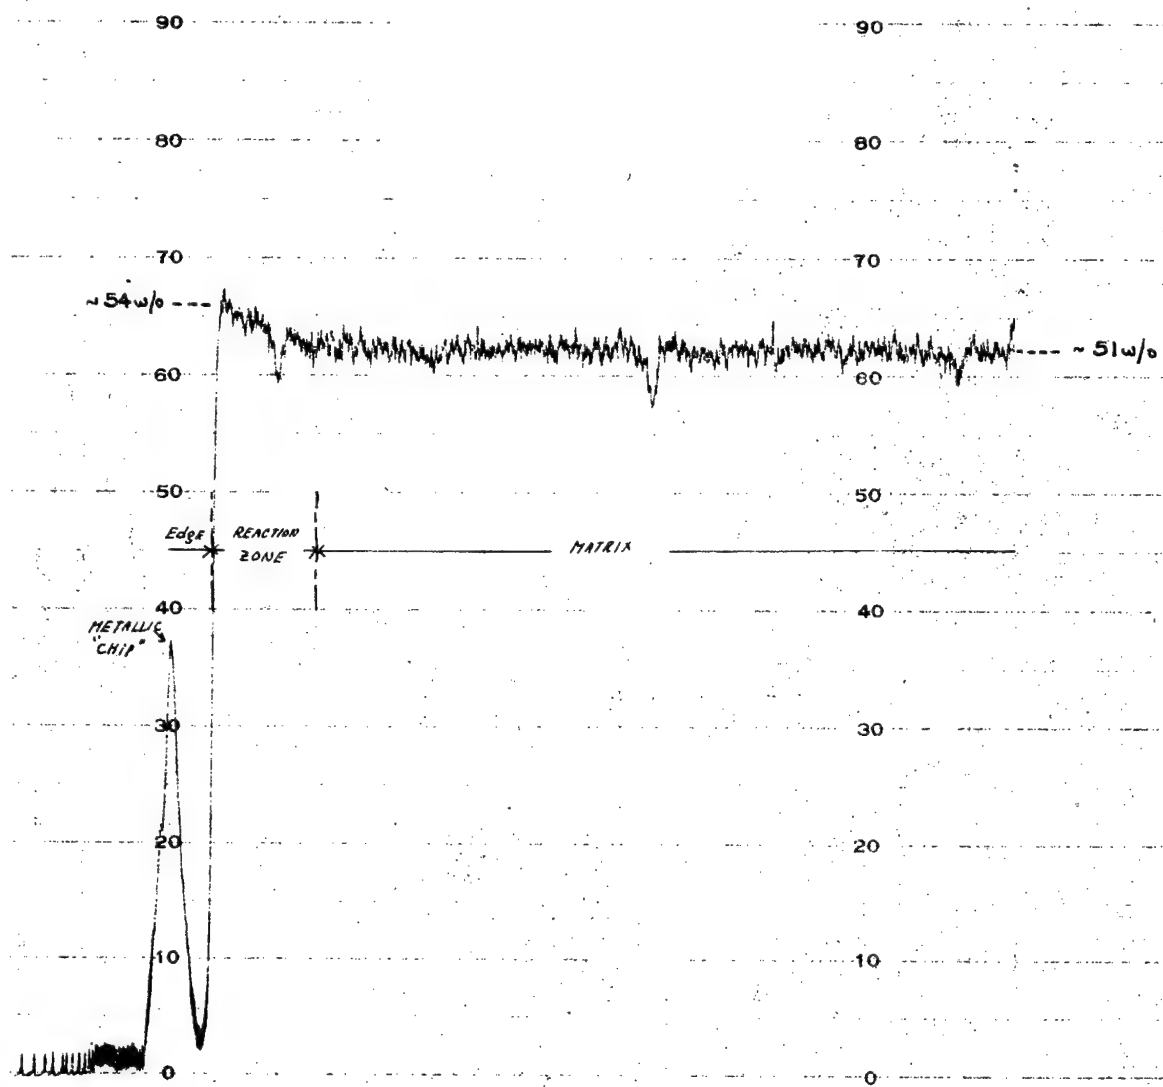
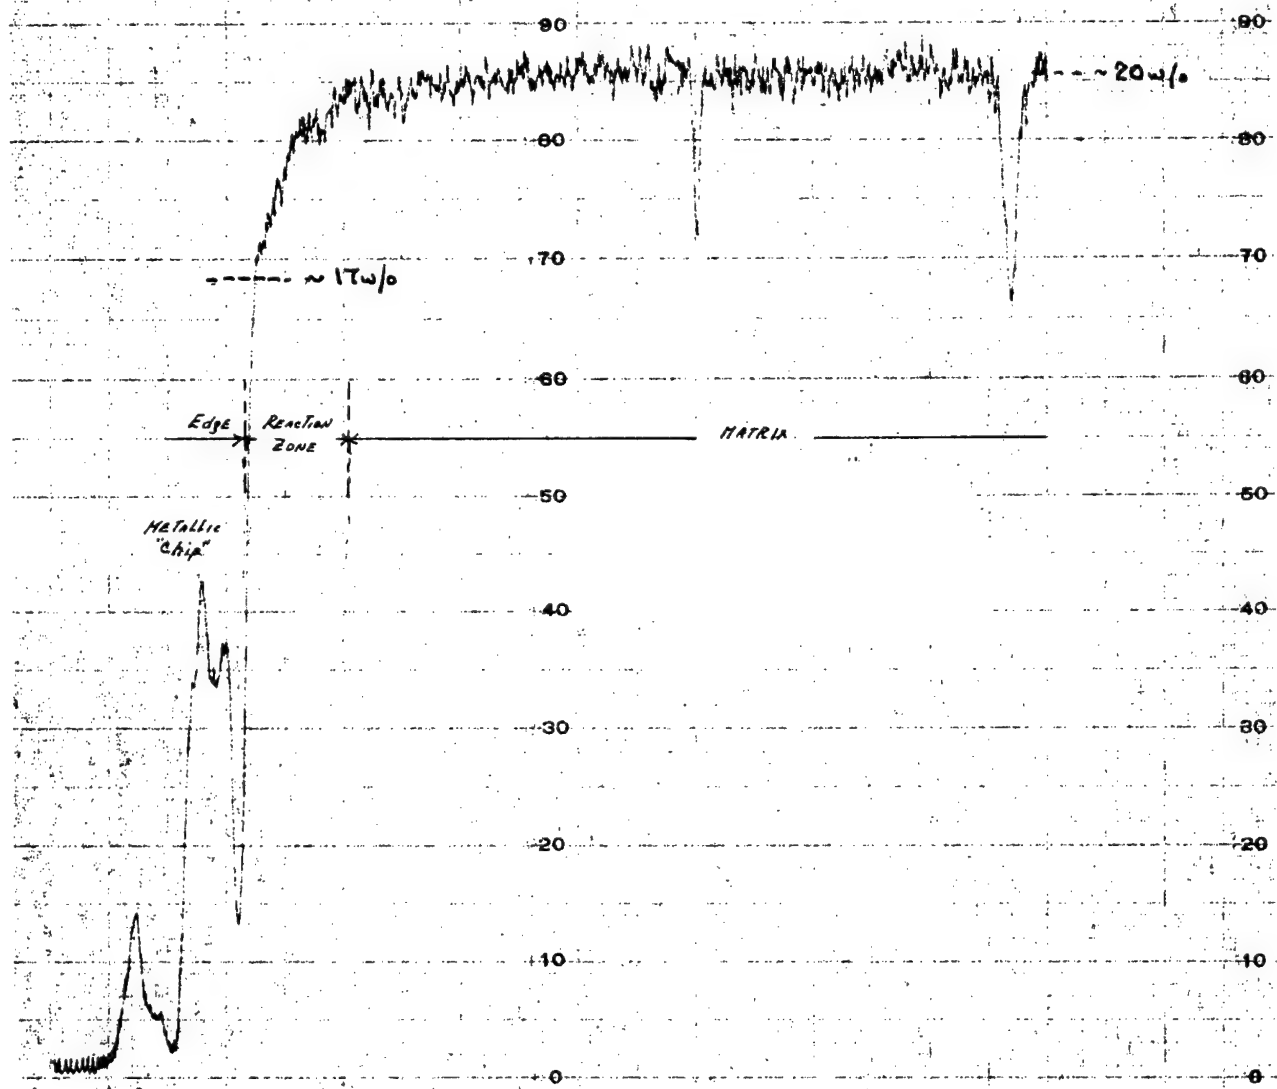
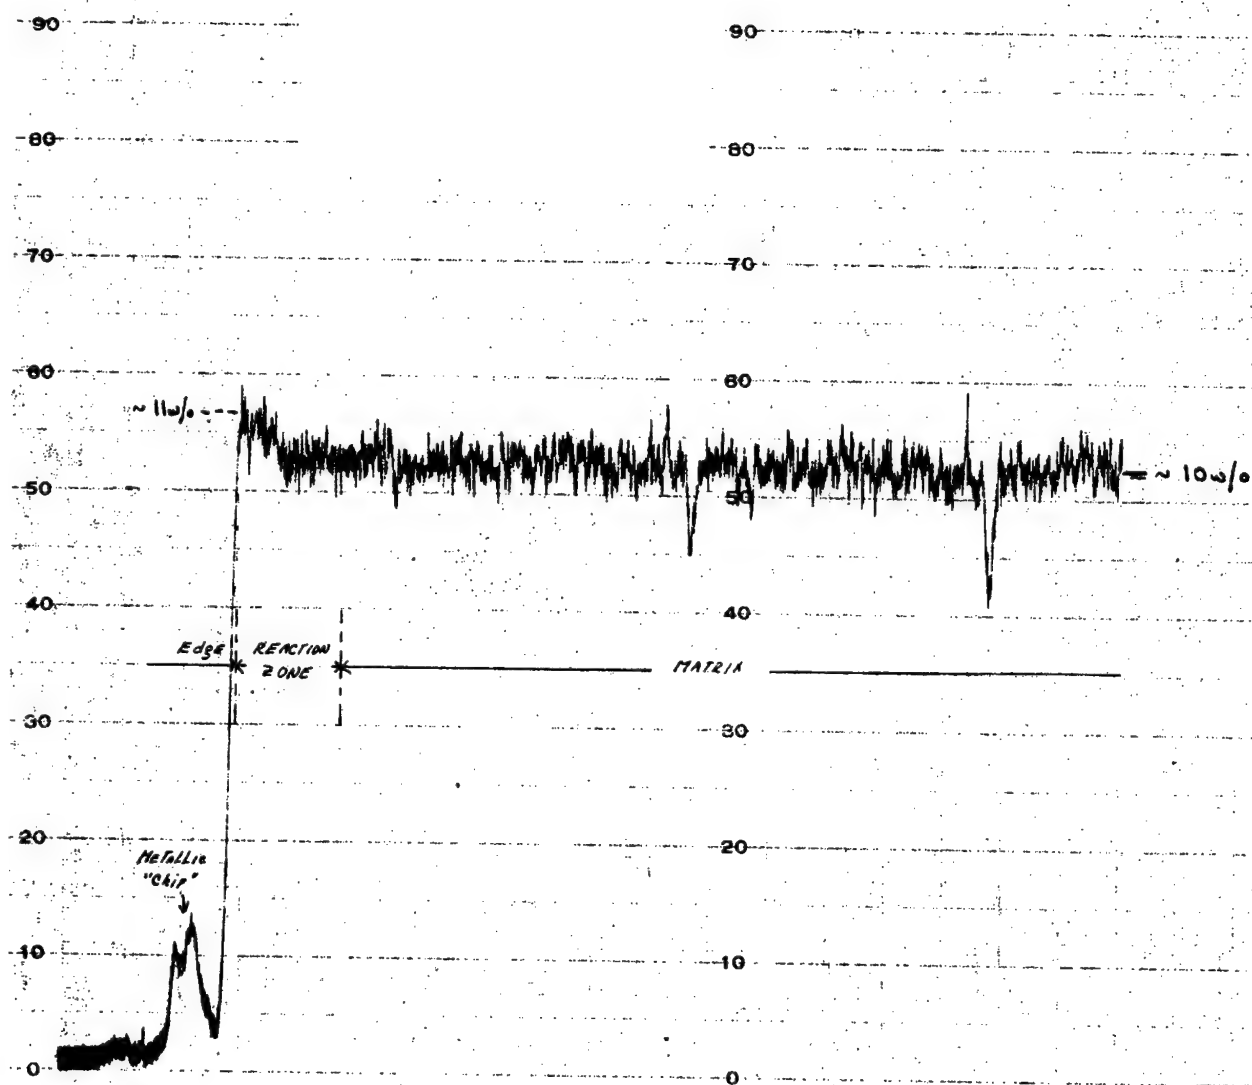
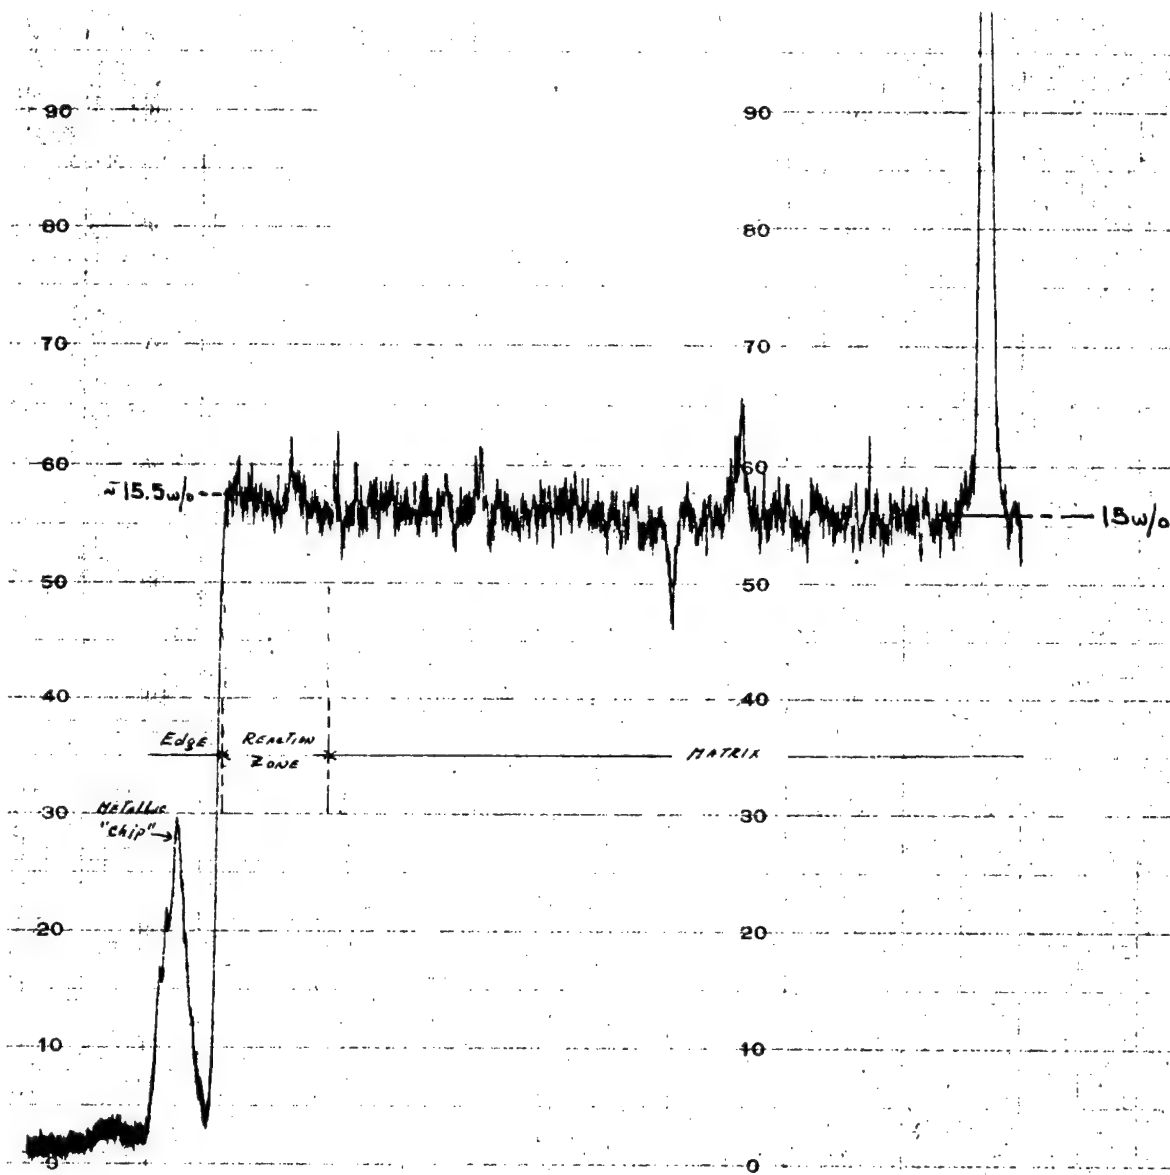
The condenser outlet specimen (see Figure 22d) revealed no visible evidence of a surface chemistry change. However, the concentration distributions (Figures 35 through 38) showed the presence of a slowly varying gradient to a depth of 25 to 30 microns. Cobalt, nickel, and tungsten showed an increase at the I.D. surface of the specimen, while chromium was found to be depleted. A small metallic chip, partially buried in the mount material, was included in the traverse. This chip was the only one noted in the area selected for analysis and is considered insignificant. Except for some zirconium in the matrix tungsten-zirconium carbides, the zirconium, titanium, and columbium concentrations were consistently less than 0.05 percent.
